Mila Elementary School - Site Drainage

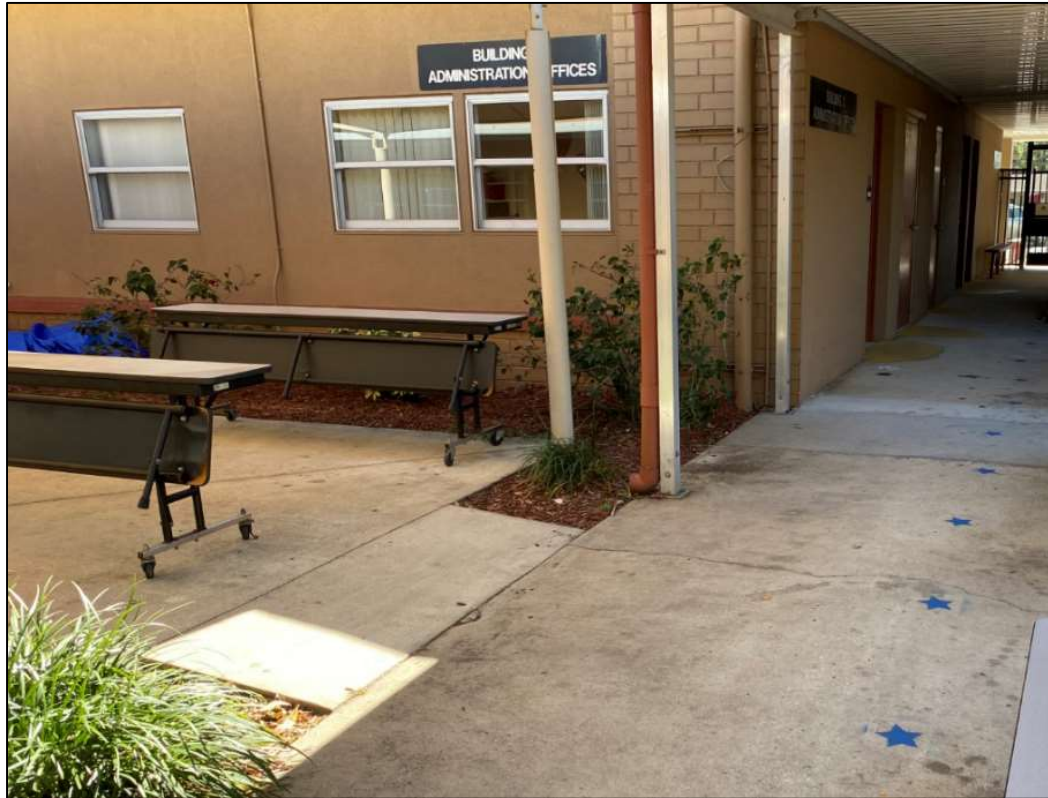
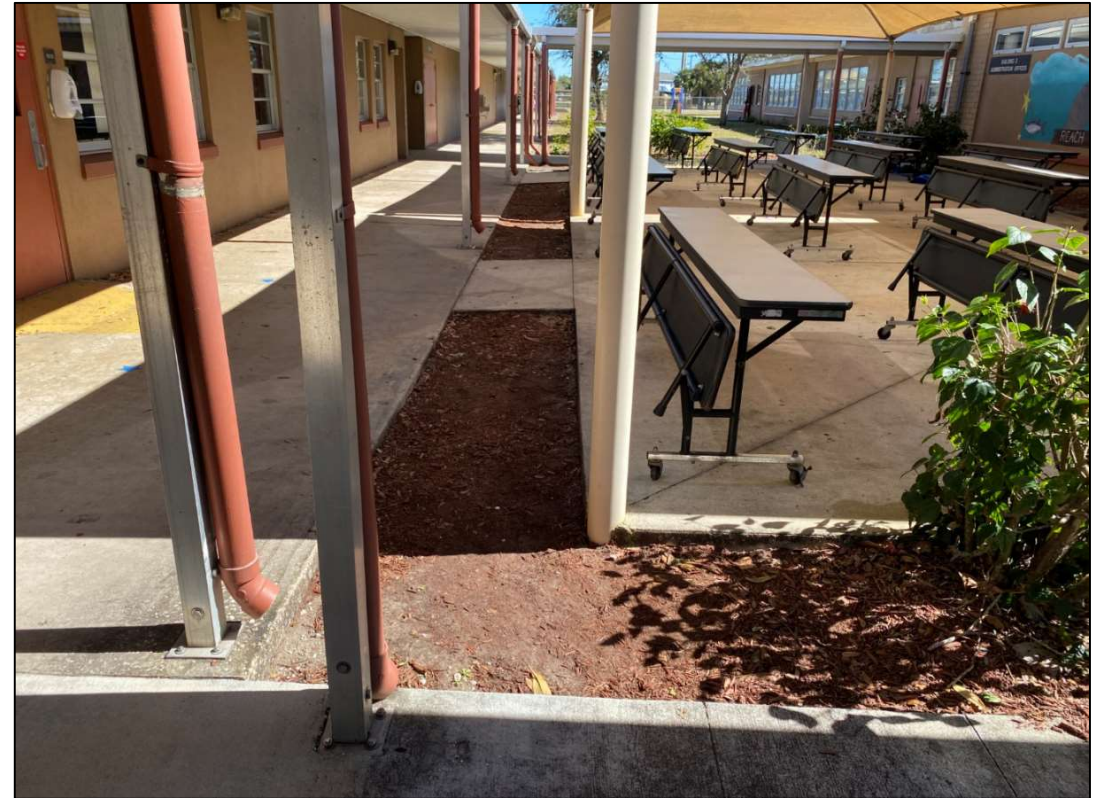
The roof downspouts drain to the courtyard which does not have a drainage outfall system. This results in flooding the courtyard and areas around the courtyard.
